Manhole Inspection Summary

Manhole # S07QQ1002MH

Insp Date: **3/14/08 12:05 PM**

Location Address: **3300 HAYWARD AVE**

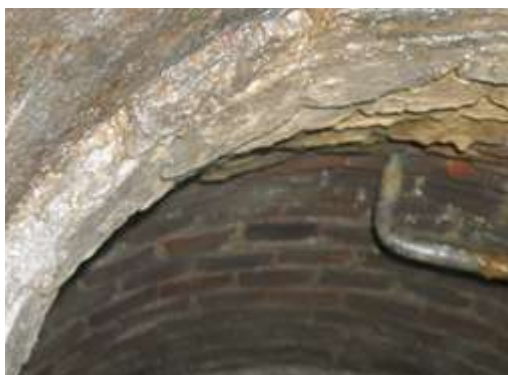
Defect 3

Infiltration: ☐ None ☐ Joint ☐ Cracks ☐ Mortar ☐ Roots ☒ **Wall**

INFILTRATION CHIMNEY WALL

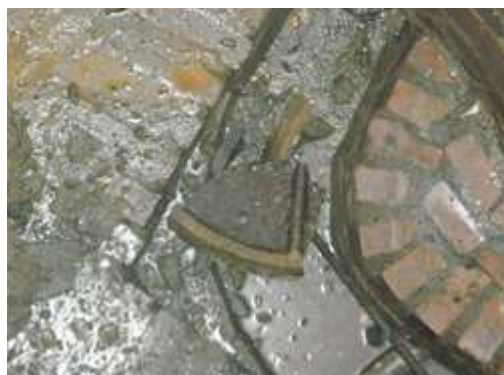
Defect 4

Condition: ☐ Sound ☐ Cracked ☐ Root Intrusion ☐ Deteriorated ☐ Leaks ☒ **Debris**

DEBRIS IN CHANNEL

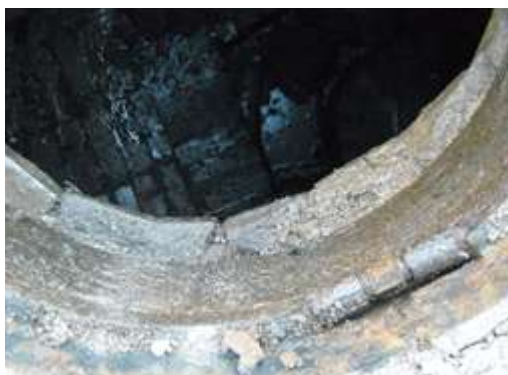
Defect 1

Frame Offset: **3** (in.) Condition: ☒ Sound ☐ Cracked ☐ Leaks

FRAME OFFSET

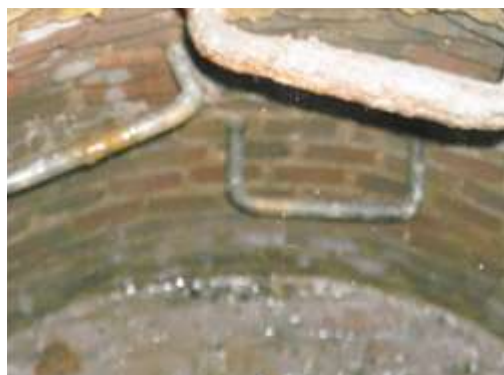
Defect 2

Steps Count: **3** Missing: **0** ☒ **Corroded**

CORRODED STEPS

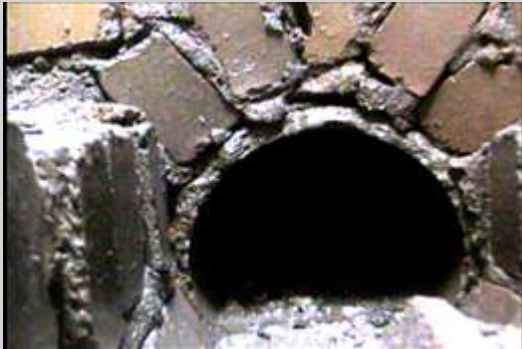
12 O'Clock Outflow

DEBRIS IN CHANNEL

Pipe Height: **4.8** (in.) Rod and Bar (Angled)
Pipe Material: **Clay** ☐ Pipe Lined
Invert Depth: **6.26** (ft.) Flow Characteristics: **None**
Deposits: ☐ None ☐ Mud ☒ **Sludge** ☒ **Debris** ☐ Grease
Silt Depth: **2** (in.) Deposits Extent: **Light**
Infiltration: **None** Pipe Seal Cond: **Sound**

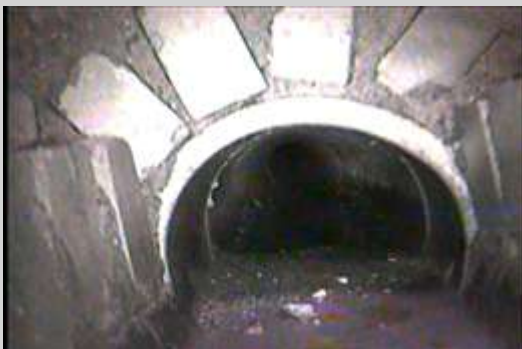
3 O'Clock Inflow

Pipe Height: **6** (in.) Rod and Bar (Angled)
Pipe Material: **Clay** ☐ Pipe Lined
Invert Depth: **6.21** (ft.) Flow Characteristics: **None**
Deposits: ☐ None ☐ Mud ☒ **Sludge** ☒ **Debris** ☐ Grease
Silt Depth: **2** (in.) Deposits Extent: **Light**
Infiltration: **None** Pipe Seal Cond: **Sound**
